Care and Feeding of Icom PW1 1,000-Watt Solid State Power Amplifiers

W6DE, July 2022

This is a compilation of replies I have made to the Groups.io PW1 on-line forum. This is loosely organized around the causes of why PW1s fail, how to protect PW1s and how to repair some PW1 failures.

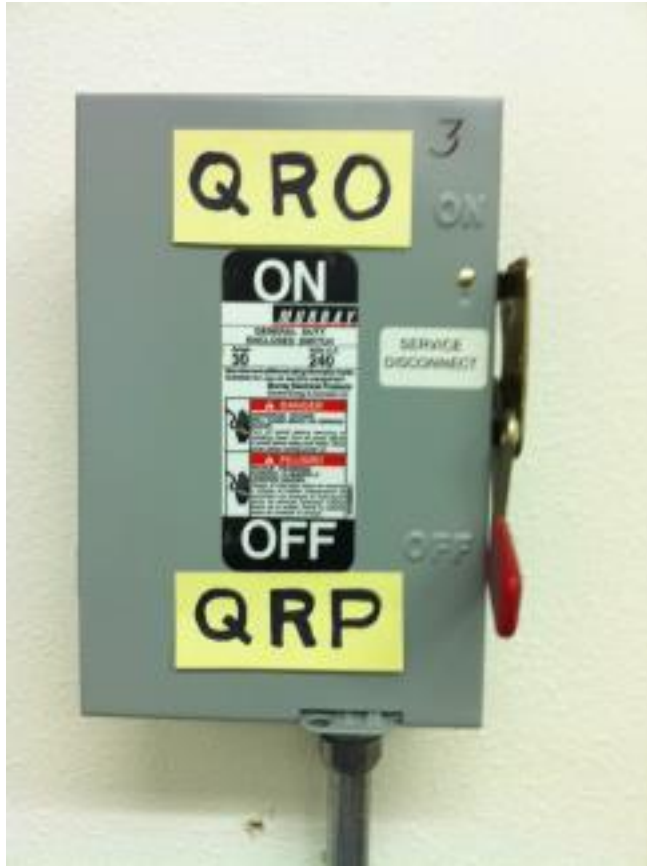
Because the PW1 is always powered, folks living in areas of lightning activity with the accompanying power spikes and failures, it is wise to unplug the power cord during these events. If you have a weather forecast predicting a Storm with Lightning and Thunder or a notice from your Electric Utility announcing a power outage; disconnect your PW1 from the power mains until the storm or outage is over.

One way to increase the survivability of a PW1 through a power fail and restoration is to remove the capability of the amplifier to operate on 120 Volts. This will make the PW1 always require a 240 Volt power connection. Removing the 120 Volt capabilities allows the amp to survive higher voltage surges. See this nice write up from AK2F: http://www.ab4oj.com/icom/pw1/psu_repair.html for more information.
